Investigation of Steel-Stringer Bridges: Superstructures and Substructures, Volume II

Final Report
October 2007

Sponsored by
the Iowa Highway Research Board (Project TR-522)
and the Iowa Department of Transportation (CTRE Project 04-184).

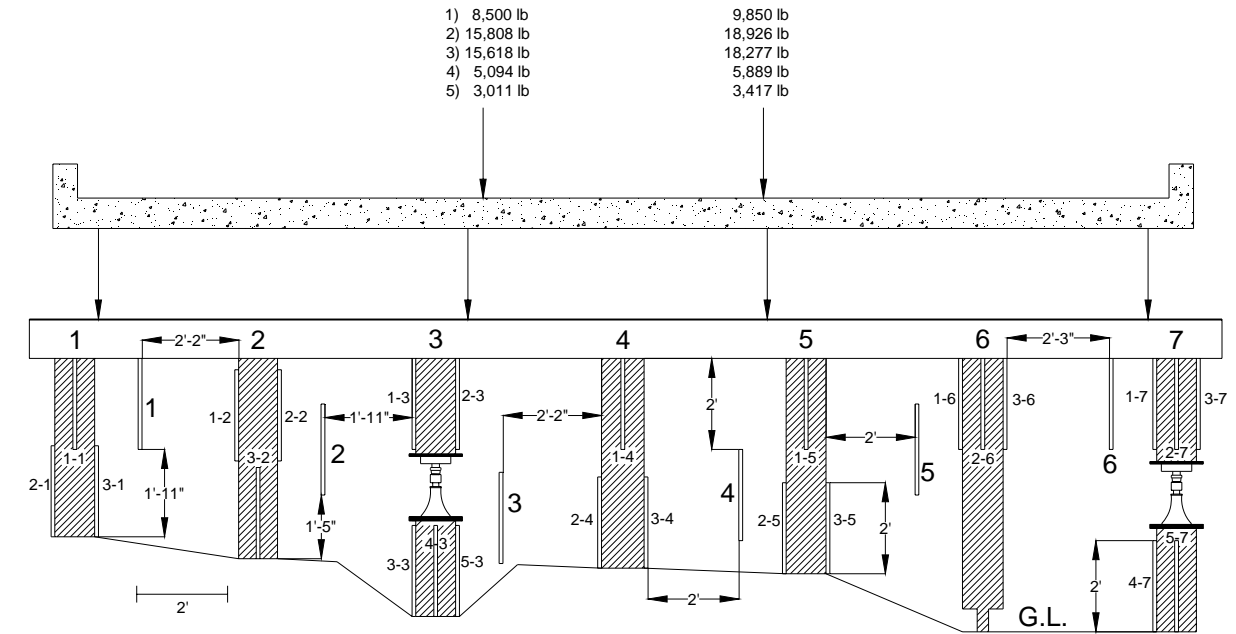
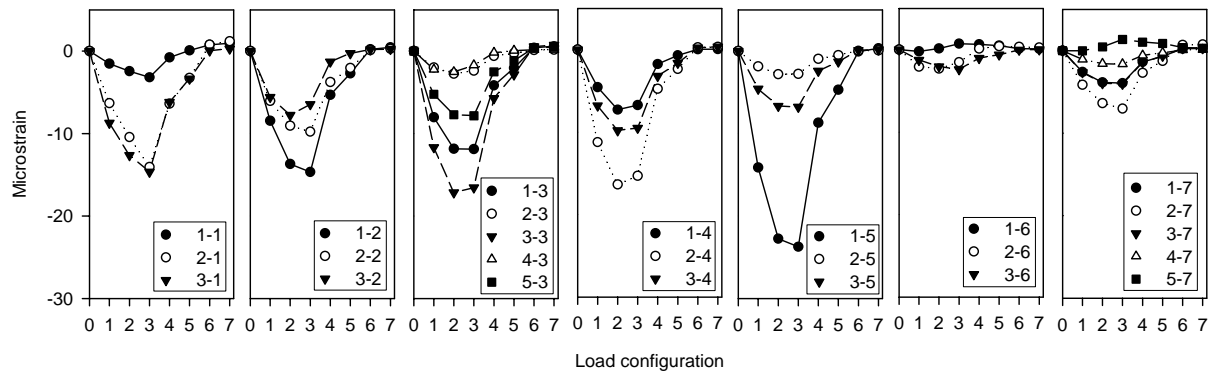
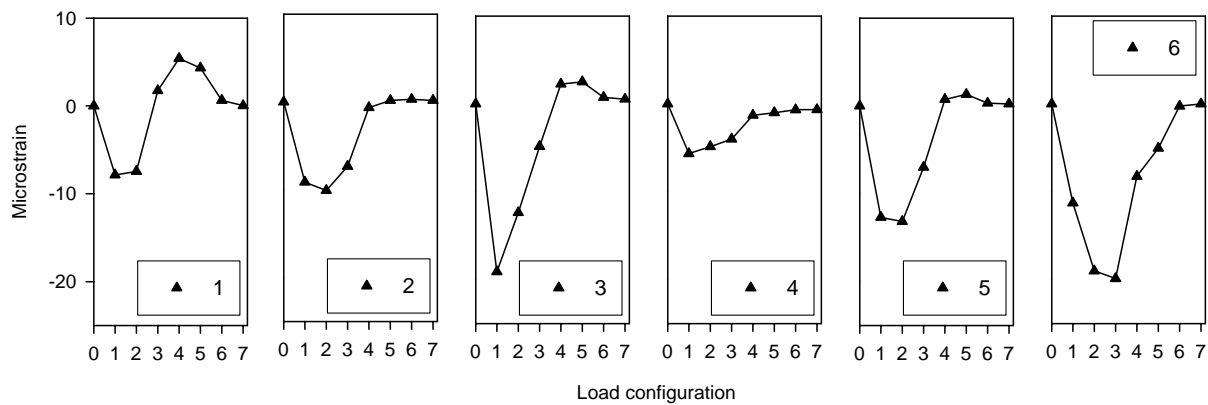
Figure 12.36. Static load test at the centerline pile Nos. 7 and 3 jacked (Bridge No. 029070 – Humboldt County)

The abutment was then loaded at the centerline of the bridge deck. The location of the loads, the pile strain measurements, and the backwall strains are shown in Figure 12.36. Similar to previous load tests conducted at this location, the load was primarily transferred to pile nos. 3 and 5 (See Figure 12.36a). The highest strain, which was about -23 microstrains, was in pile no. 5 in load configuration 3. When compared to the nondestructive test and destructive test nos. 1 and 2, the strain at pile no. 3 was reduced by approximately 40%. As a result, the backwall strain between pile nos. 3 and 4 increased by 60%. Similarly, the strain measured in pile no. 7 was reduced by approximately 35% compared to the nondestructive test at this location, whereas the backwall strain between pile nos. 6 and 7 increased by 45% increase. The same percent increase in backwall strain was recorded in destructive test no. 1. As mentioned earlier, removing a timber section and replacing it with the mechanical jack reduced the load carrying capacity of the piles, which transferred more axial load to the backwall. The percent load resisted by pile nos. 3 and 7 relative to the total load was 13 and 9%, respectively.

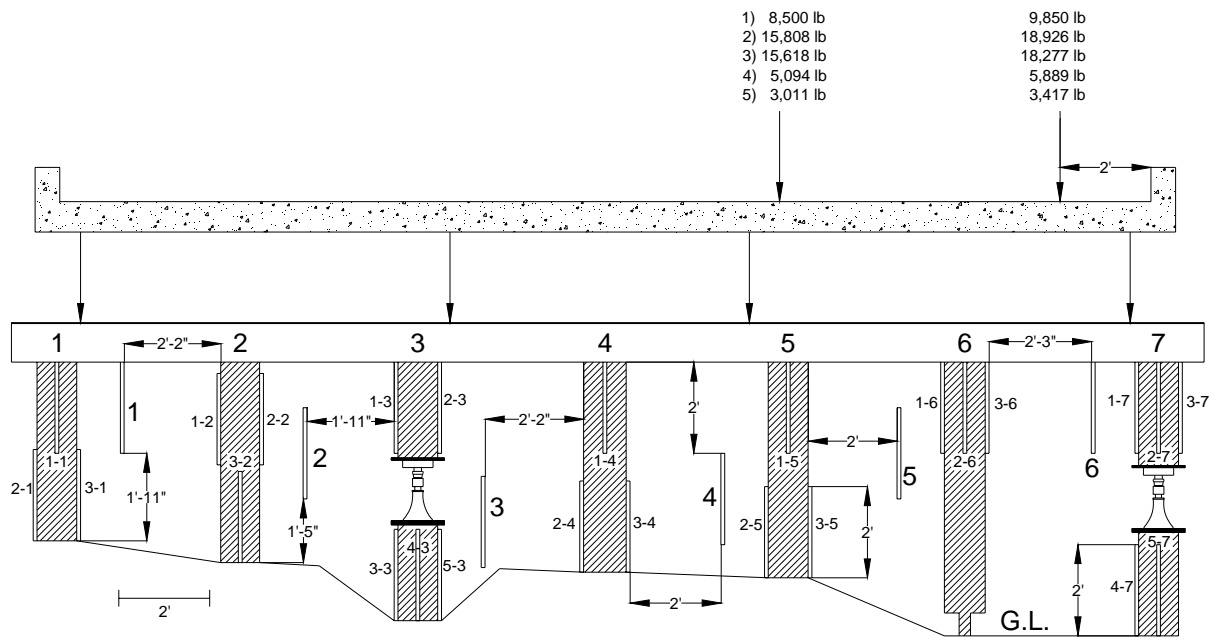
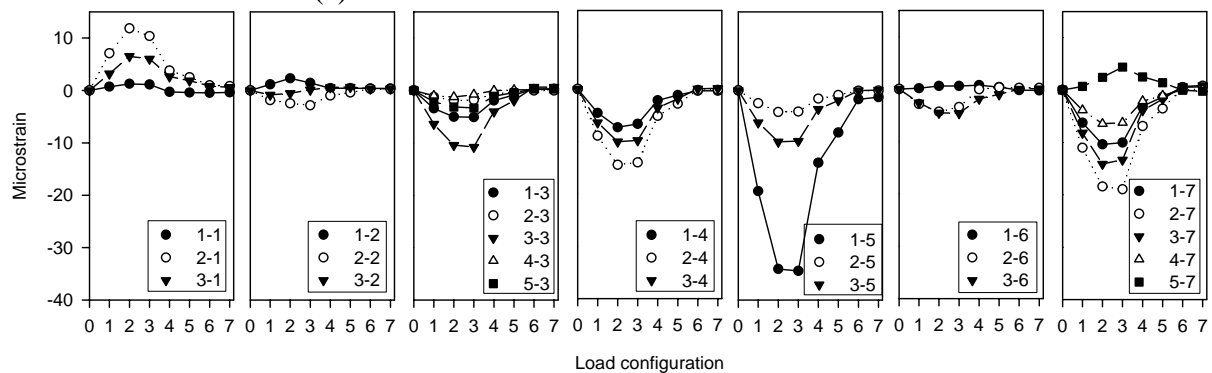
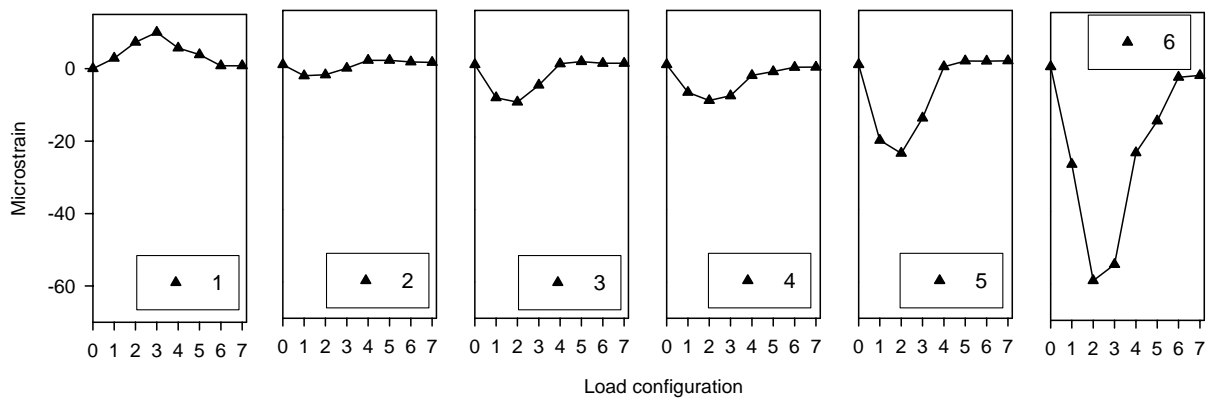
Figure 12.37. Static load test at the south edge pile Nos. 7 and 3 jacked (Bridge No. 029070 – Humboldt County)

The east abutment was finally loaded at the south edge of the bridge. The location of the axial loads, which were offset 2 ft from the curb, pile strain measurements, and backwall strains are shown in Figure 12.37. The results show a decrease in strain in pile nos. 3 and 7 compared to the nondestructive test and test no. 1 where pile no. 7 was jacked. The strain measurement of pile no. 3 decreased by about 25, 34, and 36% in load configuration 3 compared to the nondestructive test, test no. 1, and test no. 2, respectively. The decrease in pile no. 3 strain was coupled with an increase in backwall strain between pile nos. 3 and 4. The backwall strain at this location increased by 33 and 28% compared to the nondestructive test and test no. 1, respectively. The results also show that the strain in the adjacent pile no. 4 increased by 27 and 6% compared to the nondestructive test and destructive test no. 1, respectively. This indicated that part of the load that was resisted by pile no. 3 was transferred to the adjacent pile no. 4. However, no significant increase in the strains in pile no. 2 was observed. In the north edge test, most of the strain increase was noted in pile no. 2, whereas at the south edge, most of the strain increase occurred in pile no. 4. It can therefore be concluded that when an interior pile is partially deteriorated, the load may not be distributed equally among adjacent piles, and the live load location should be taken into consideration.

Similar to pile no. 3, the strain measured in pile no. 7 decreased by approximately 50 and 30% compared to the nondestructive test and test no. 1, respectively. This was accompanied by an increase in backwall strain due to partial bearing of the pile cap on the backwall. The percent increase was 55 and 11% compared to the nondestructive test and test no. 1, respectively. Furthermore, the strain in the adjacent pile no. 5 increased by 40% compared to the nondestructive test. No considerable difference was noted relative to the strains measured during test nos. 1 since pile no. 7 was jacked during both tests. When compared to test no. 2 (pile no. 7 removed) the results demonstrate that the backwall strain between pile nos. 6 and 7 was reduced by 25%, and the strain in pile no. 5 was also reduced by 13%. The percent load carried by pile nos. 3 and 7 were 6 and 27%, respectively.

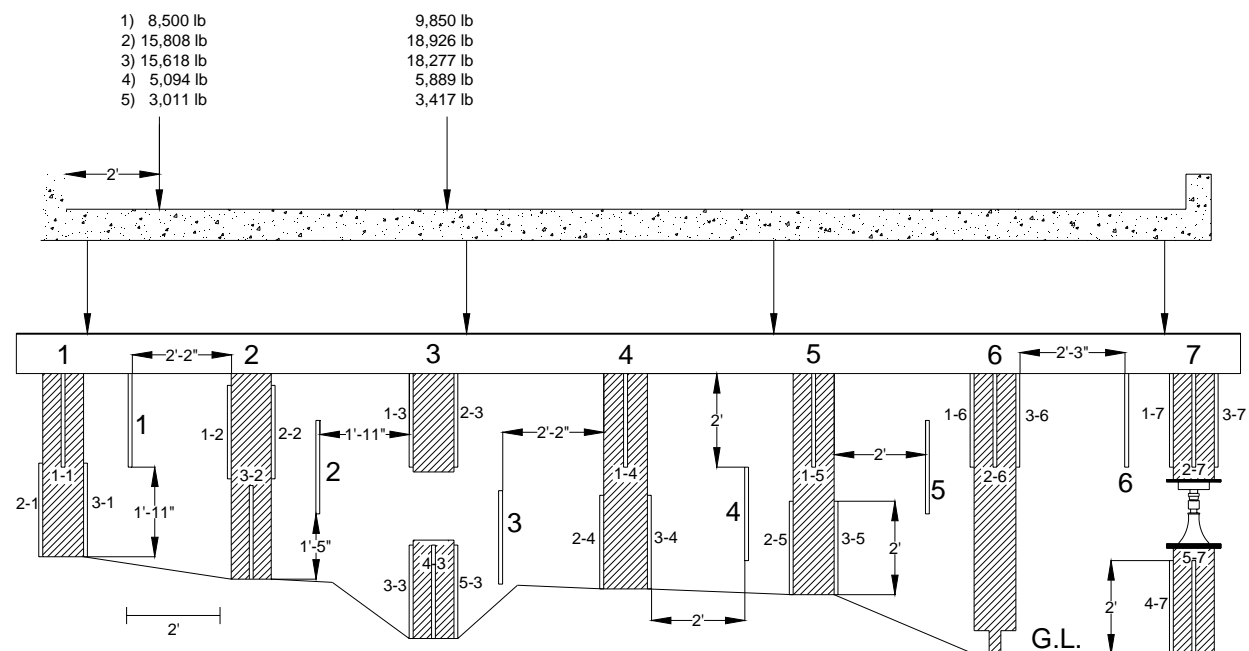
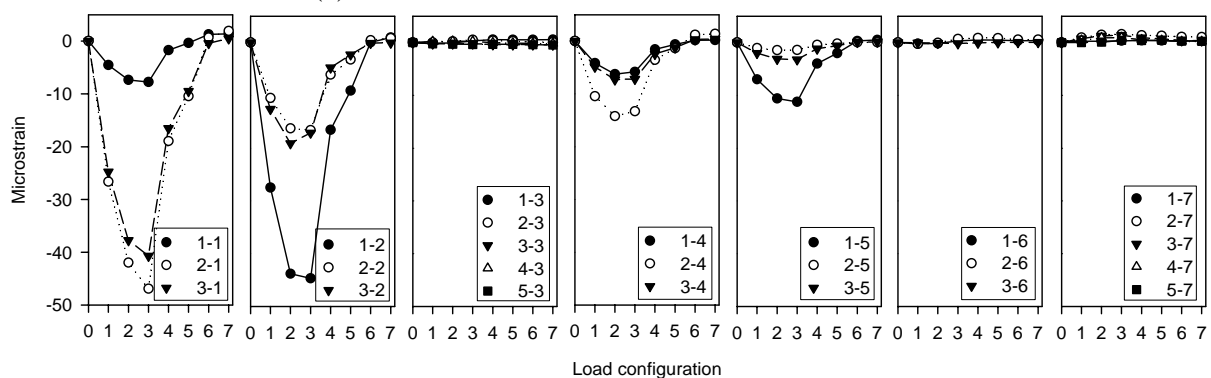
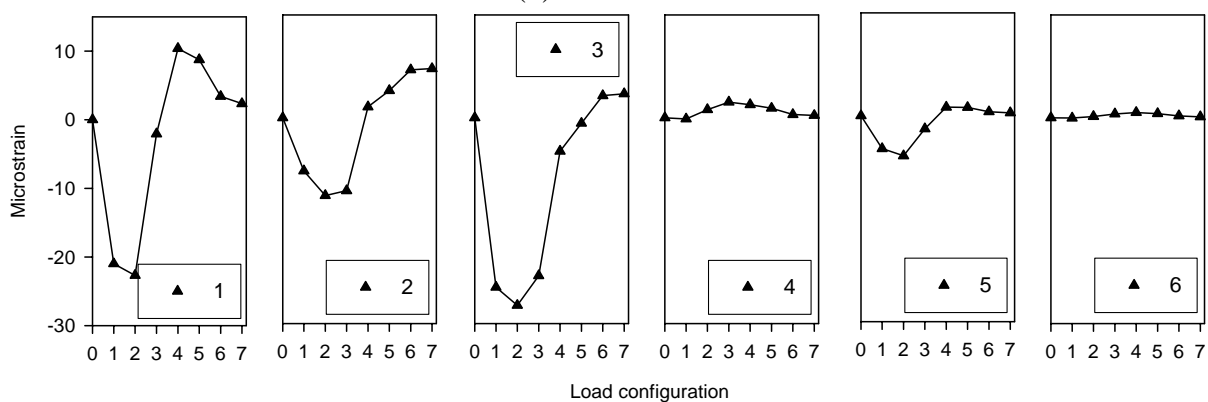
Figure 12.38. Static load test at the north edge with pile no. 3 removed and pile no. 7 jacked (Bridge No. 029070 – Humboldt County)

The east abutment was first loaded at the north edge of the bridge. The location of the axial loads, pile strain measurements, and backwall strains are shown in Figure 12.38. Removing pile no. 3 resulted in an increase in the strains in pile nos. 2 and 4 compared to those that occurred during destructive test no. 3, where pile no. 3 was jacked. The strain measured in pile nos. 2 and 4 increased by 27 and 16%, respectively. Due to the removal of pile no. 3 and partial bearing of the pile cap on the backwall, the backwall between pile nos. 3 and 4 resisted higher loads as evidenced by the increase in strain, which was about 70%.

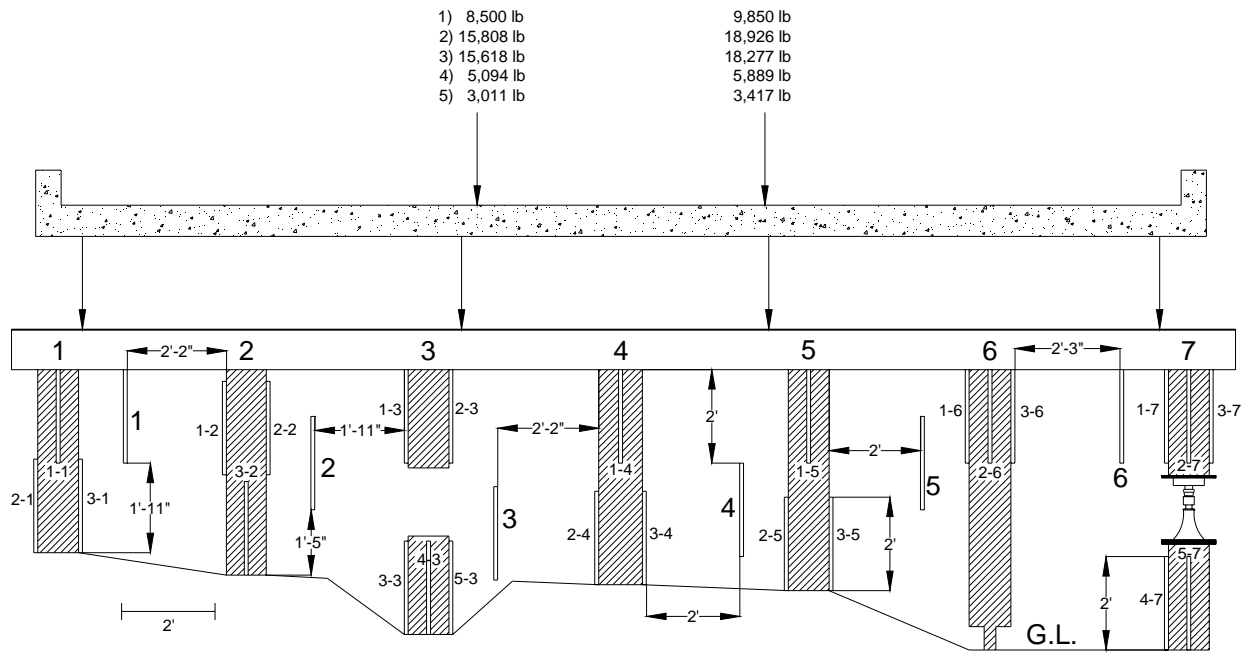
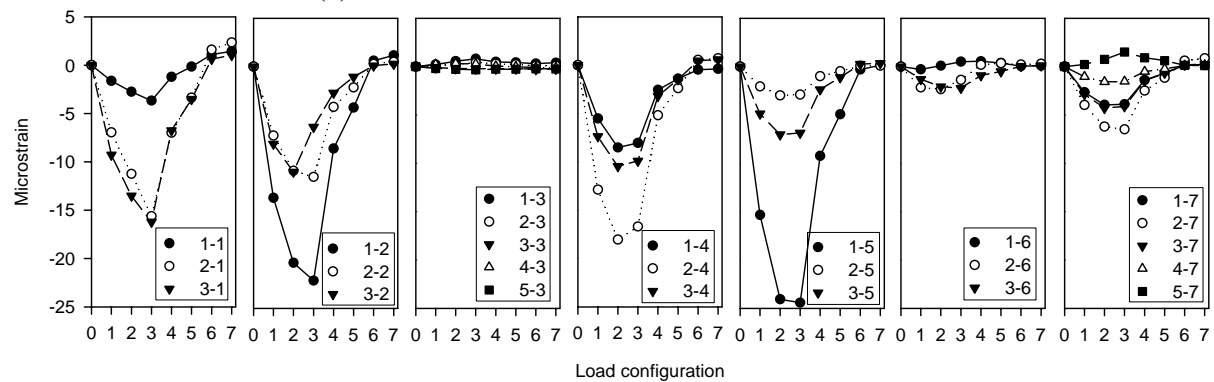
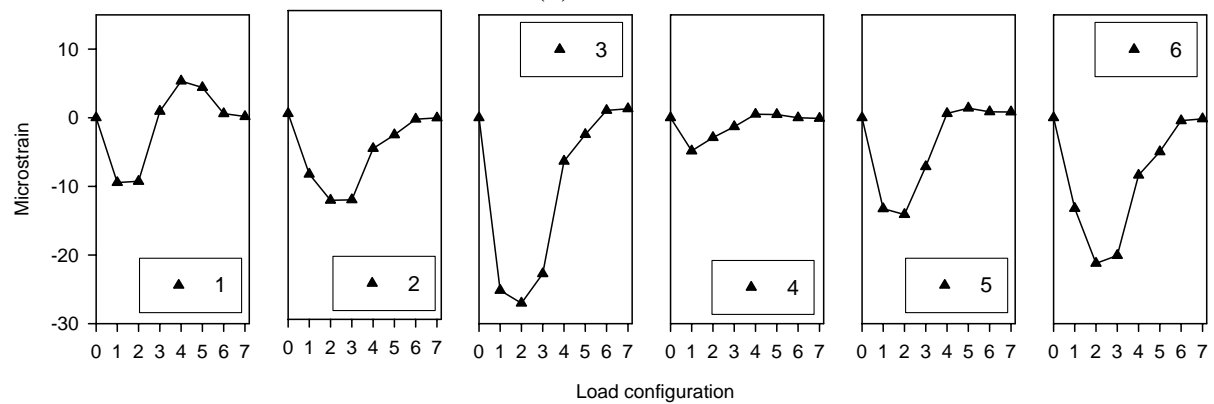
Figure 12.39. Static load test at the centerline pile No. 3 removed and pile No. 7 jacked (Bridge No. 029070 – Humboldt County)

Loading the abutment at the centerline of the bridge deck resulted in an increase in strain at pile nos. 2 and 4 by 50 and 12%, respectively, compared to the strains that occurred in destructive test no. 3 (See Figure 12.39b). Furthermore, a 40% increase in the backwall strain between pile nos. 3 and 4 was measured (See Figure 12.39c). The percent load carried by pile no. 7 was 9%, which is equal to that measured during test no. 3.

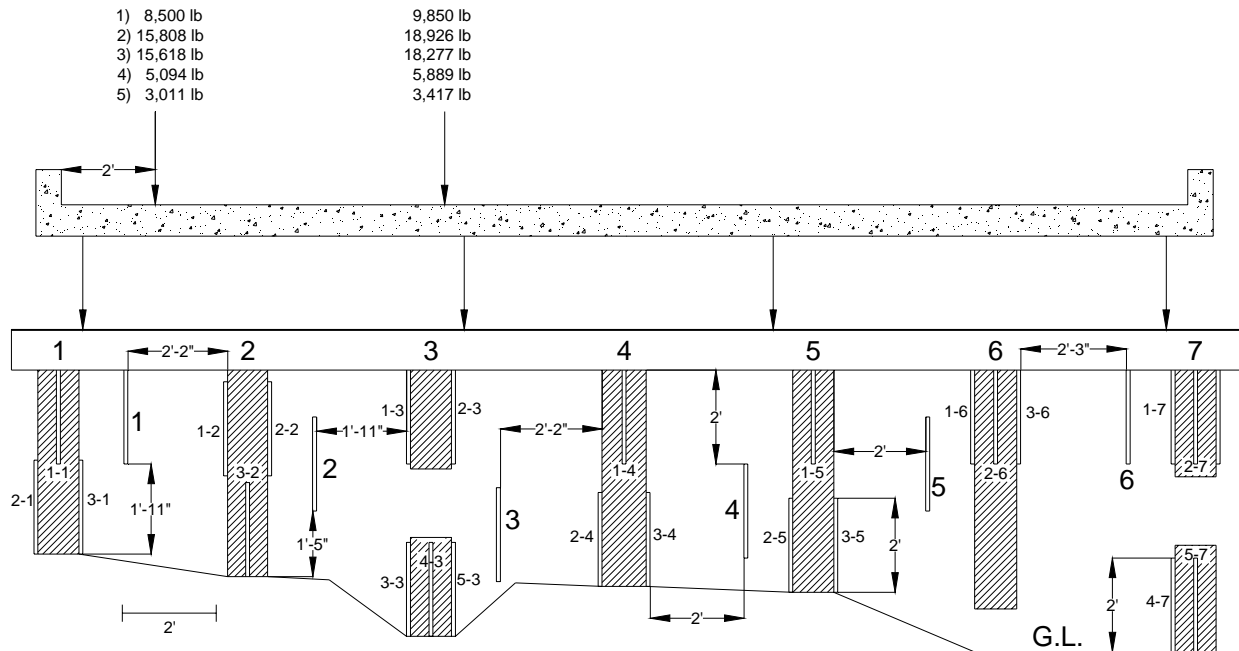
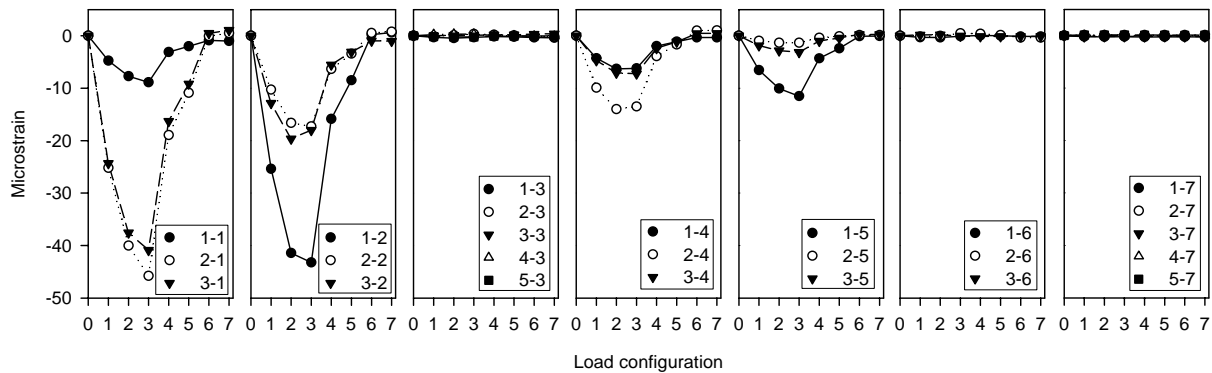
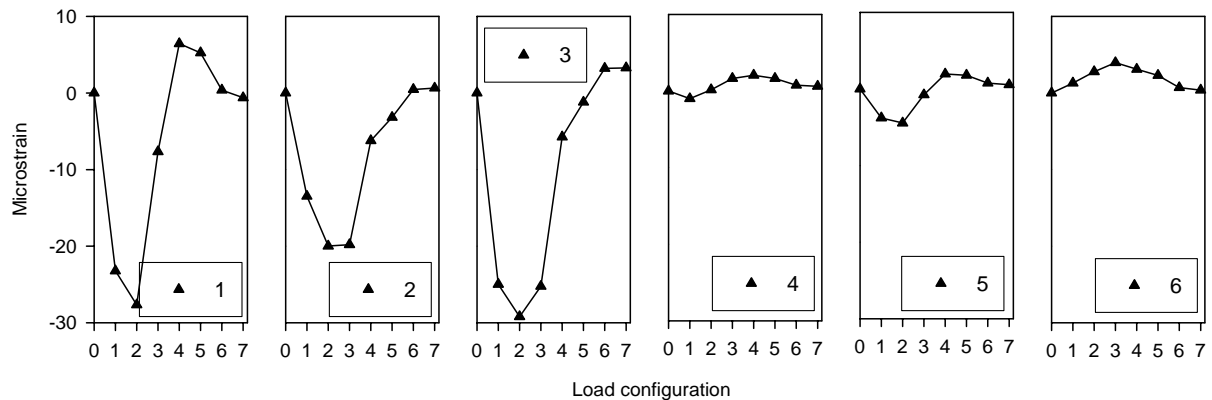
Figure 12.43. Static load test at the north edge with pile Nos. 3, 6 and 7 removed (Bridge No. 029070 – Humboldt County)

The first load test was performed with the load applied at the north edge of the bridge. Removing pile no. 6 did not have major influence on the strains developed throughout the substructure (See Figure 12.43) since pile and backwall strains were similar to those measured during test no. 5 (north edge test).

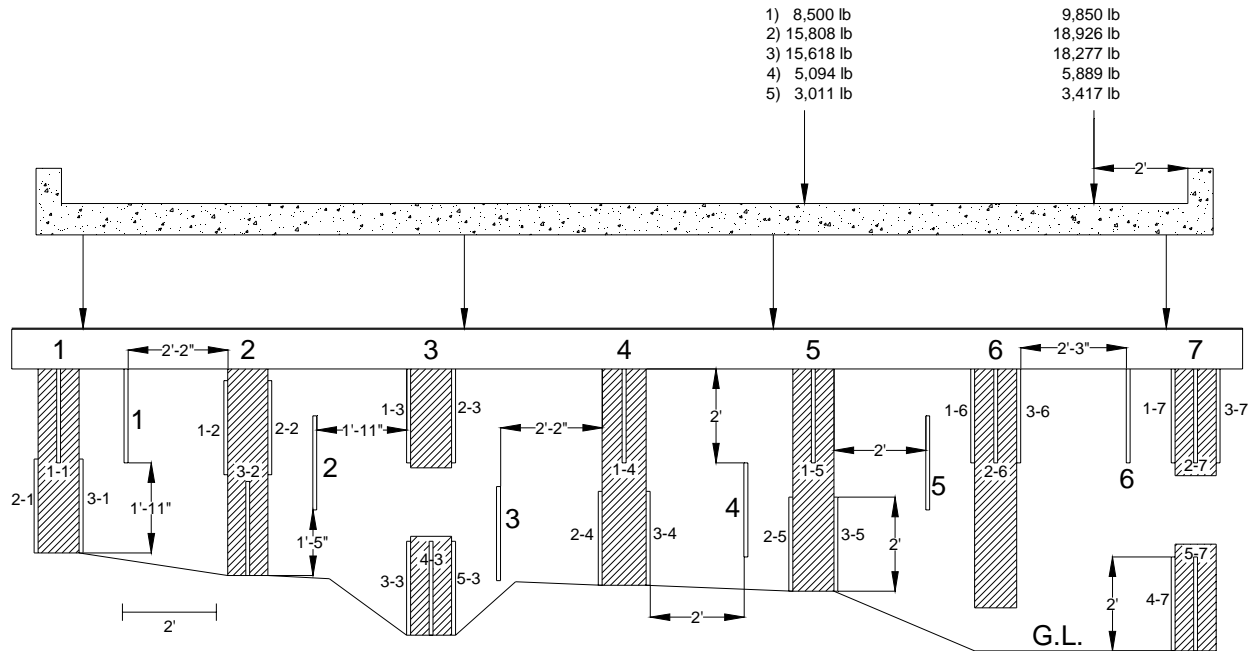
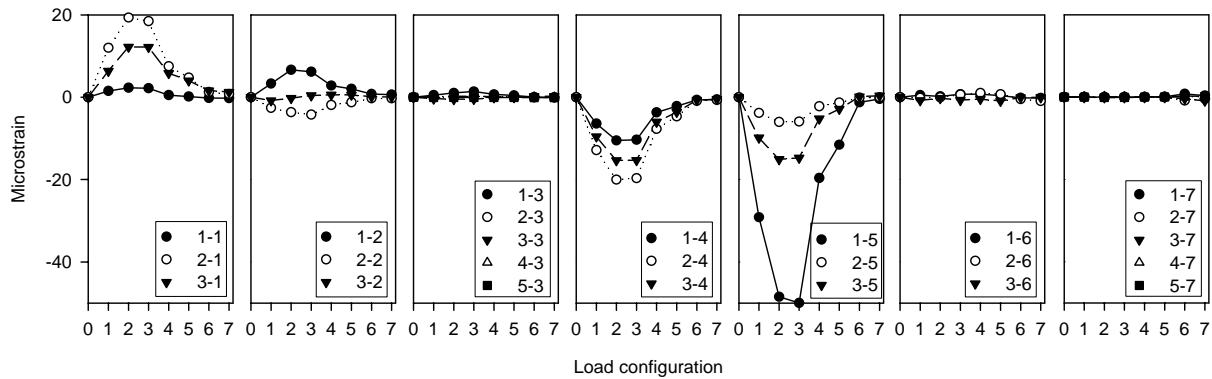
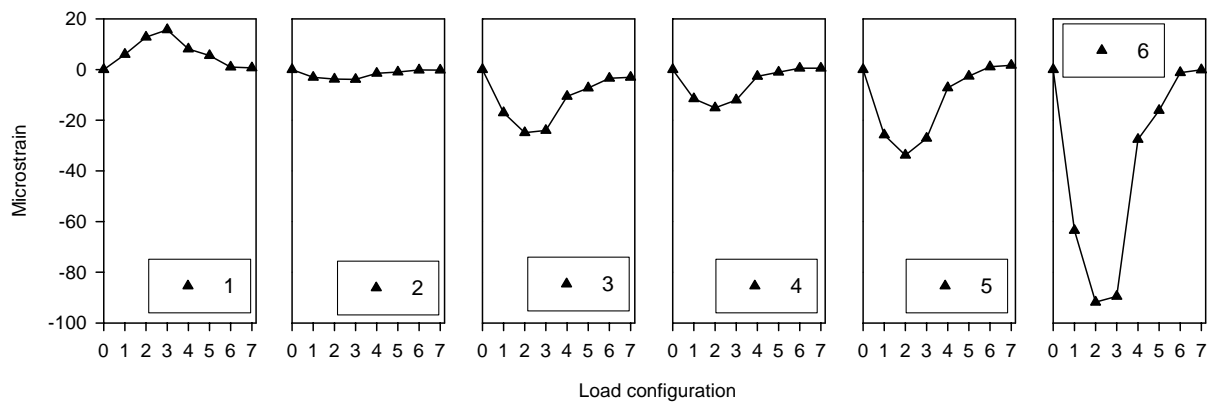
Figure 12.45. Static load test at the south edge with pile Nos. 3, 6 and 7 removed (Bridge No. 029070 – Humboldt County)

The location of the axial loads, pile strain measurements, and backwall strains are shown in Figure 12.45. Loading the abutment at the south edge of the bridge resulted in an increase in pile no. 5 strain by approximately 25% compared to test no. 5, where only pile nos. 3 and 7 were removed. In addition, removing pile no. 6 resulted in a higher positive strains measured at pile nos. 1 and 2 compared to test No. 5. The strain measured in pile nos. 1 and 2 increased by 7 and 24%, respectively. Furthermore, the negative backwall strain between pile nos. 5 and 6 increased by approximately 10%, while the backwall strain between pile nos. 6 and 7 increased by about 15%. The positive backwall strain between pile Nos. 1 and 2 increased by 20%.

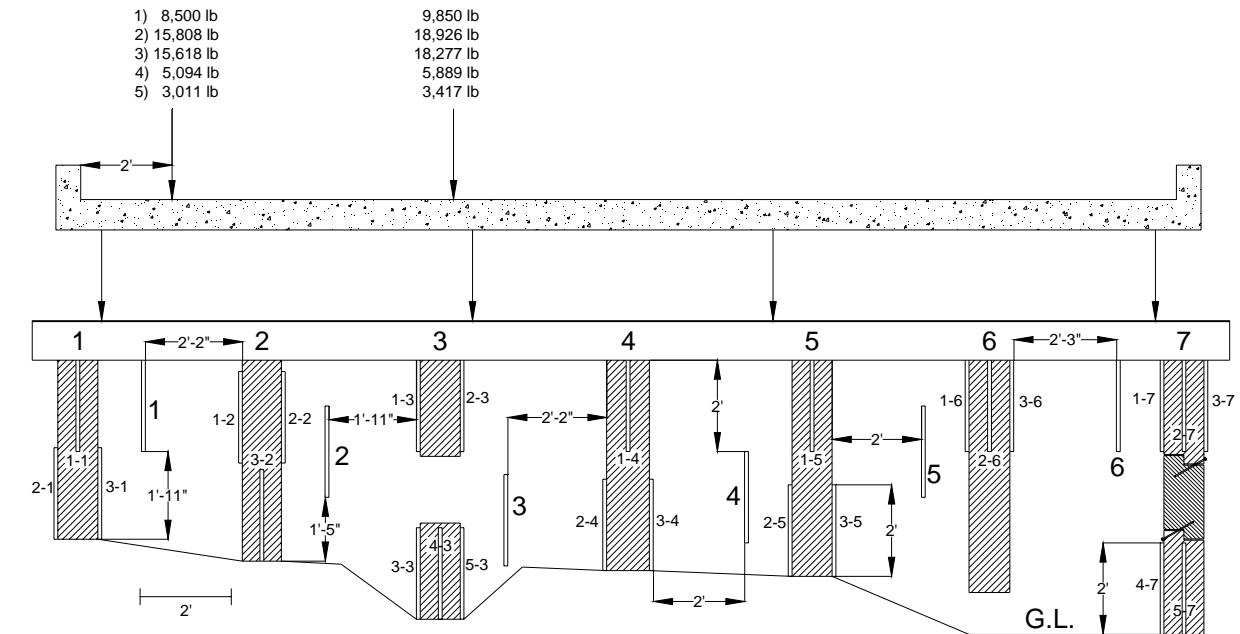
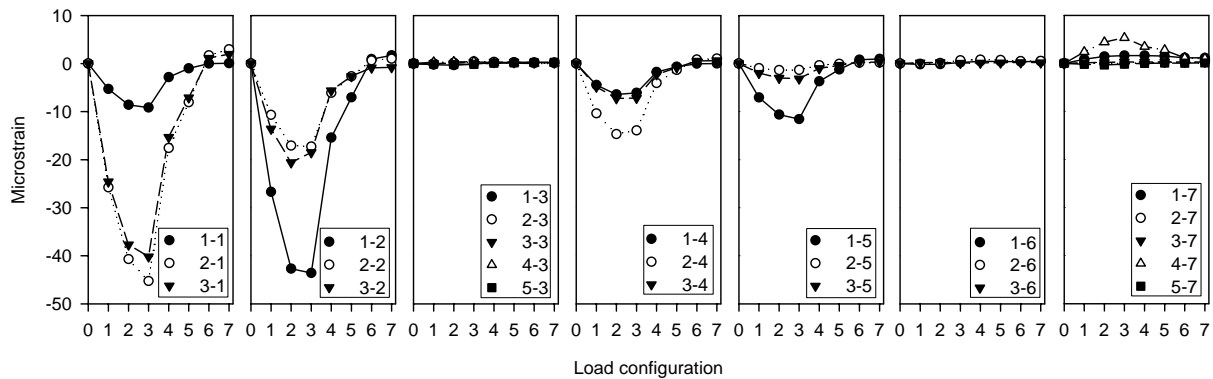
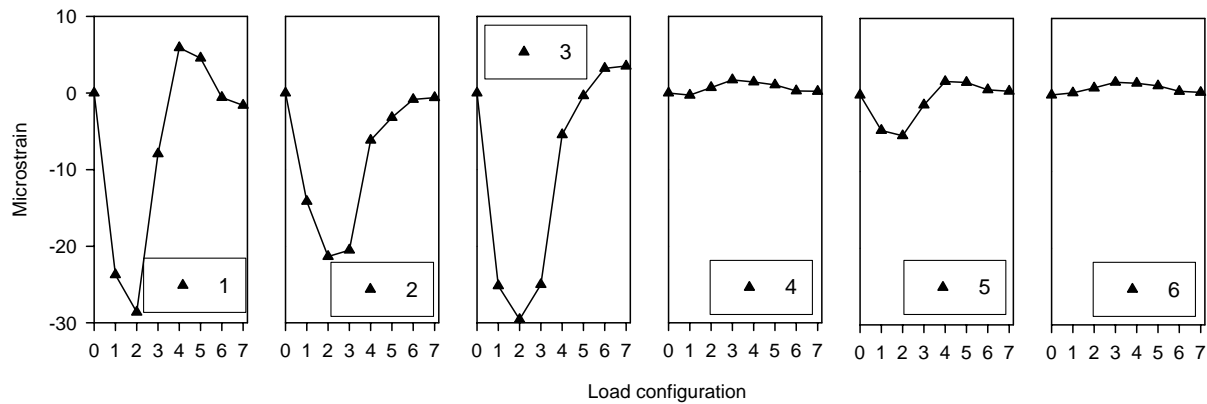
Figure 12.46. Static load test at the north edge with pile nos. 3 and 6 removed and pile no. 7 repaired (Bridge No. 029070 – Humboldt County)

The first load test was carried out with the loading at the north edge of the bridge (See Figure 12.46). The pile and backwall strain measurements were similar to those measured during test nos. 5 and 6. When the abutment is loaded at the north edge of the bridge, almost no load is resisted by pile no. 7, which is reflected by the negligible pile strain.

This test was carried out to determine the feasibility of repairing localized deteriorated sections of the timber pile. The section removed from pile no. 7 was replaced with a new pile section, which was spliced and attached to the existing pile using two steel screws. Three tests were conducted with the loading applied along the north, centerline, and south edges of the bridge, and the percent strain occurring in pile no. 7 during each load case was measured.

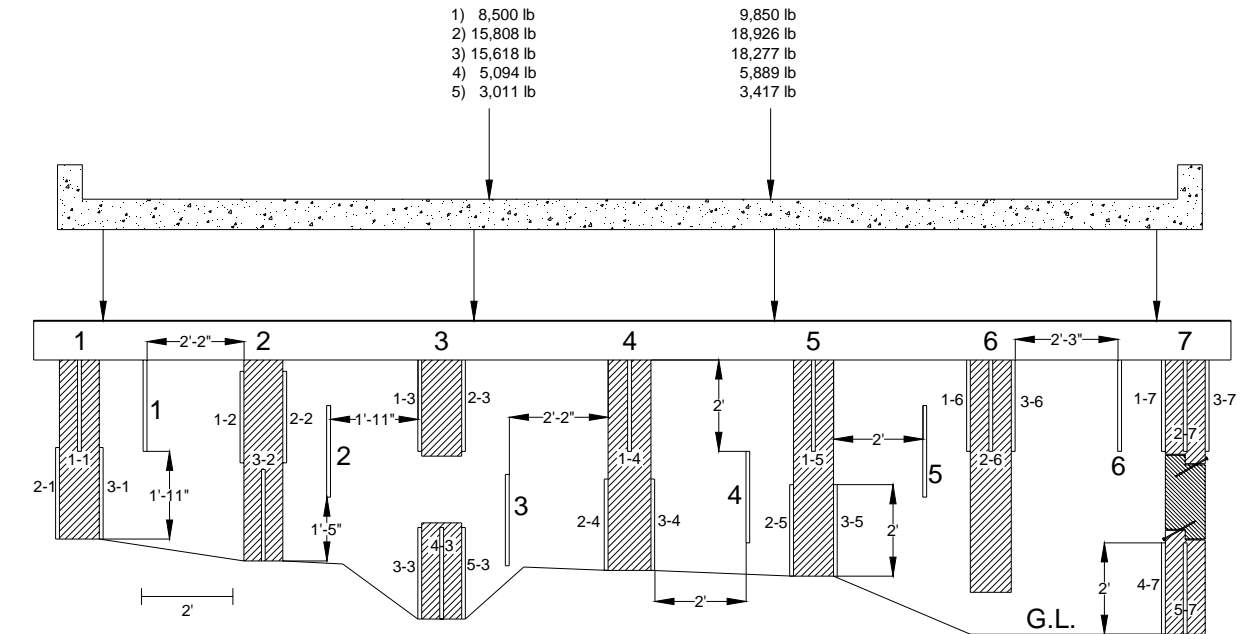
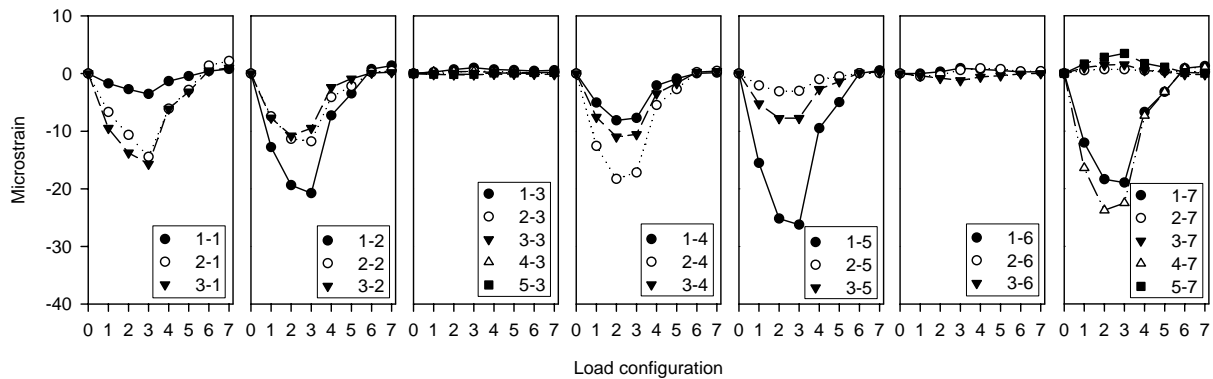
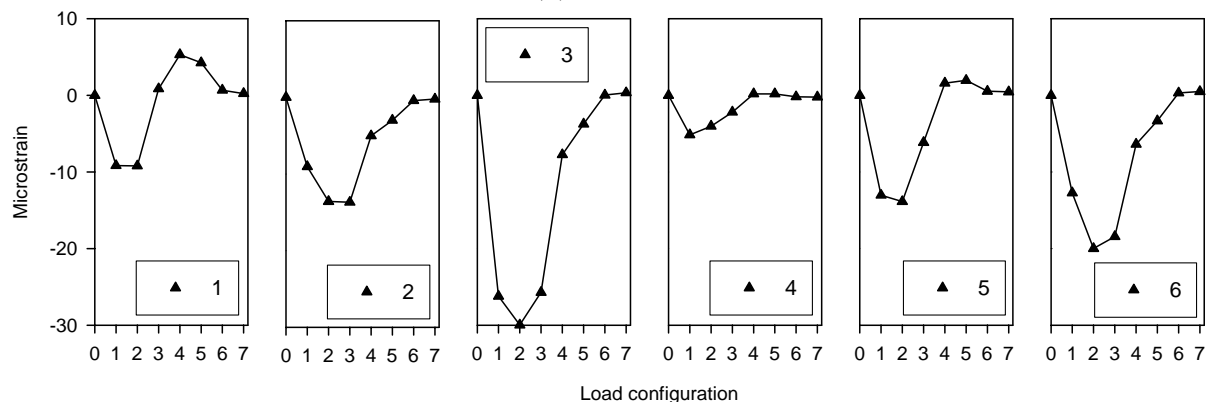
Figure 12.47. Static load test at the centerline with pile Nos. 3 and 6 removed and pile No. 7 repaired (Bridge No. 029070 – Humboldt County)

The pile and backwall strain measurements resulting from loading the abutment at the centerline of the bridge deck are shown in Figure 12.47. The results indicate the success of the pile repair method in restoring part of the capacity of pile no. 7 as evidenced by the pile strain measurement, which was about -24 microstrains in load configuration 2. The pile repair resulted also in a reduction of the strain measured in pile no. 5 by about 15% compared to test no. 5. The backwall strain between pile nos. 6 and 7 was also reduced by 45%. The strain measured in pile no. 7 was 3 times higher than that measured during destructive test no. 4 (pile no. 3 removed and pile no. 7 jacked). The pile strains, however, were only recorded by strain transducers 1-7 and 4-7 (See Figure 12.47b).

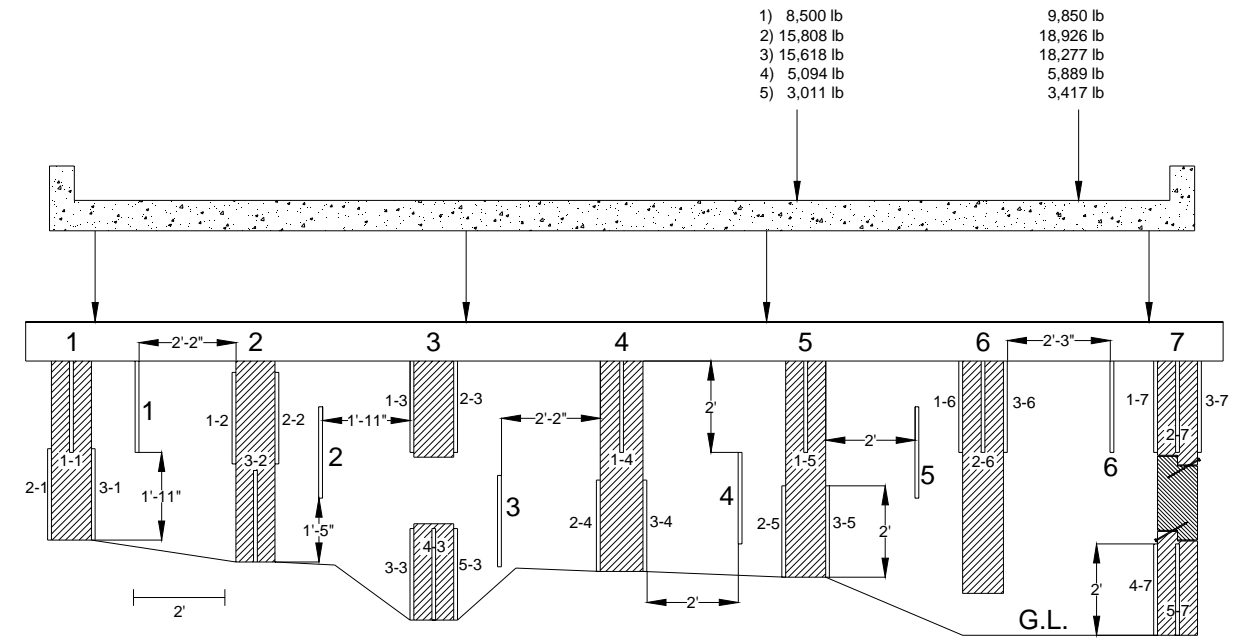
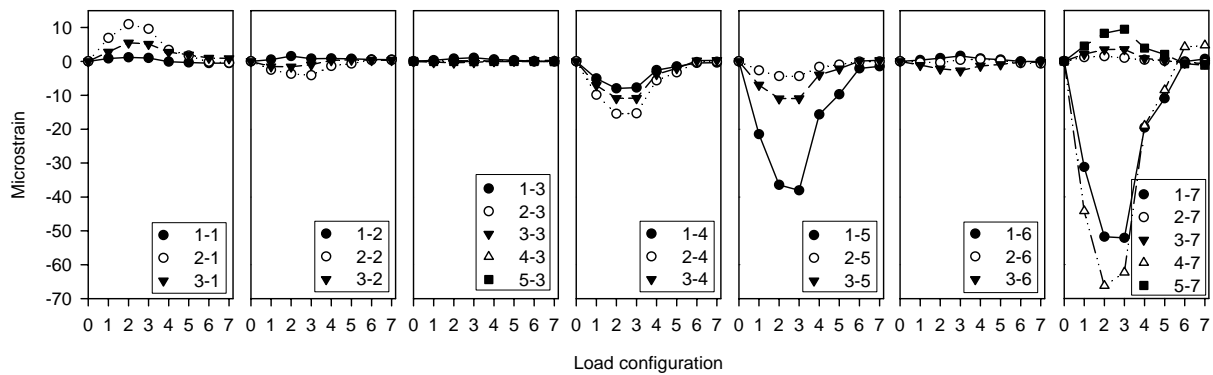
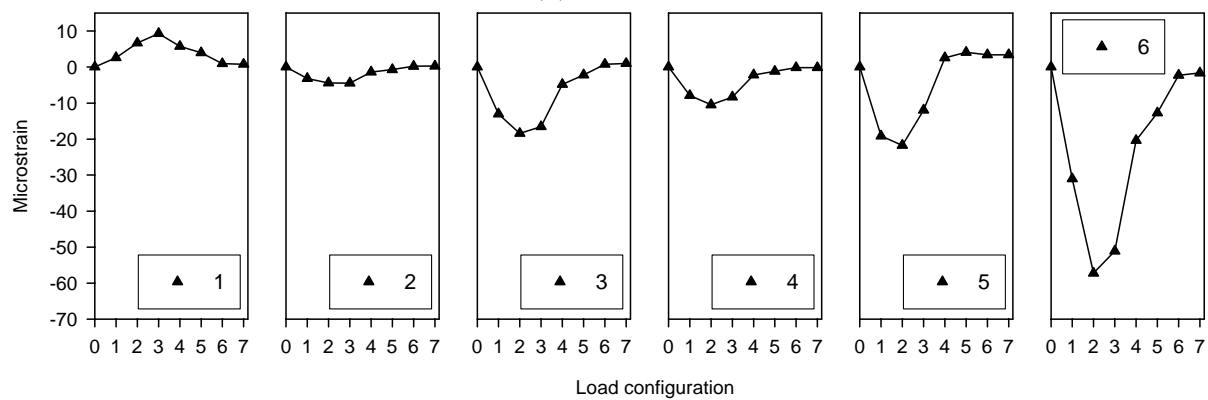
Figure 12.48. Static load test at the south edge with pile nos. 3 and 6 removed and pile no. 7 repaired (Bridge No. 029070 – Humboldt County)

The east abutment was finally loaded with the loading at the south edge of the bridge. The pile and backwall strains are shown in Figure 12.48. Similar to the centerline load test, repairing pile no. 7 reduced the strain in the adjacent pile no. 5 by 25%. Furthermore, the backwall strain between pile nos. 6 and 7 was reduced by 40%. The strain in pile no. 7 was about 3.5 times higher than that recorded during destructive test no. 4 (pile no. 3 removed and pile no. 7 jacked). Repairing pile no. 7 also resulted in reducing the positive strains in pile nos. 1 and 2 during test no. 5 (pile nos. 3, 6, and 7 removed) by about 40 and 15%, respectively.

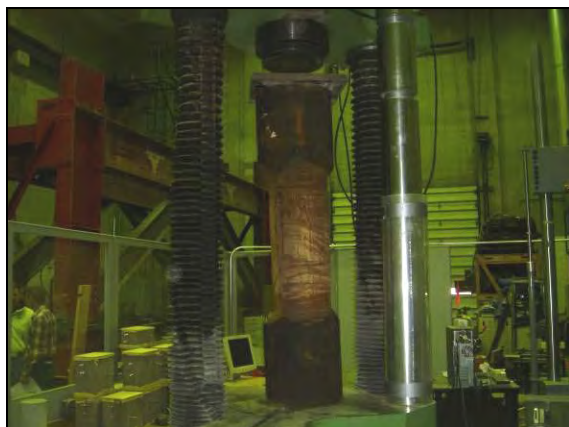
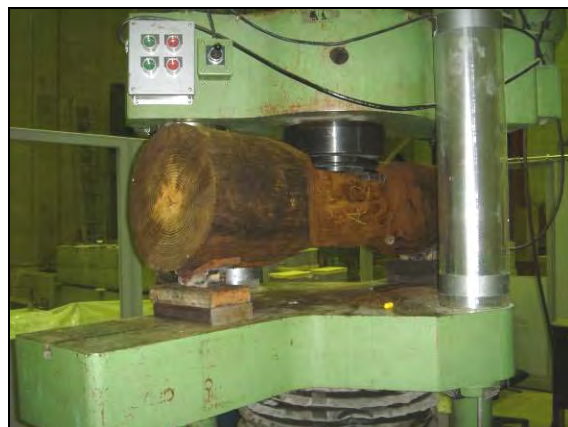
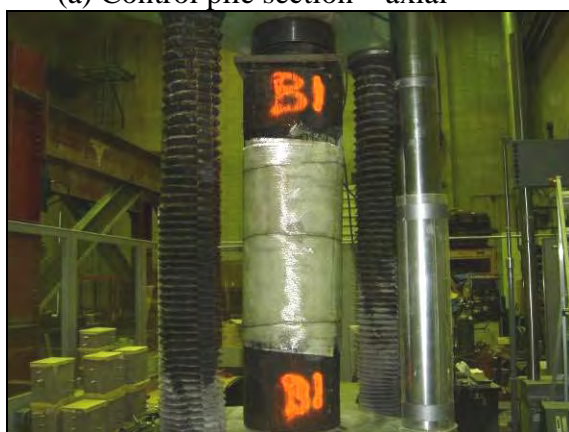
Figure 13.15. Axial and bending load tests

For each repair method, two pile sections were tested in axial compression and in bending. Figure 13.15 shows the axial compression and bending tests for the control piles and the piles repaired using methods B and C. The results of the axial compression and bending tests are shown in Figure 13.16 and Figure 13.17, respectively. Also, Table 13.3 summarizes the ultimate load measured during axial compression tests and the percent load restored for each repair method. Table 13.4 summarizes the ultimate load and deflection at failure measured during the bending tests and the percent load restored after repair. The results of the axial compression tests show that repair method A restored about 100% of the axial capacity; however, the deflection was about 10% higher. Repair methods B and C restored about 70 and 50% of their corresponding axial capacity, respectively. Compared to the control section, repair methods A, B, and C restored about 120, 102, and 88% of the load, respectively. The selected repair methods, therefore, have the potential of restoring the axial capacity of partially deteriorated timber piles. The results of the bending tests illustrate that repair method C restored about 70% of the intact pile ultimate load, which is the highest percent restoration observed. Repair methods A and B restored about 50 and 20% of the ultimate load, respectively. Repair method B showed high deflection prior to failure. Compared to the control section, repair methods A, B, and C restored about 80, 40, and 175% of the ultimate load, respectively.

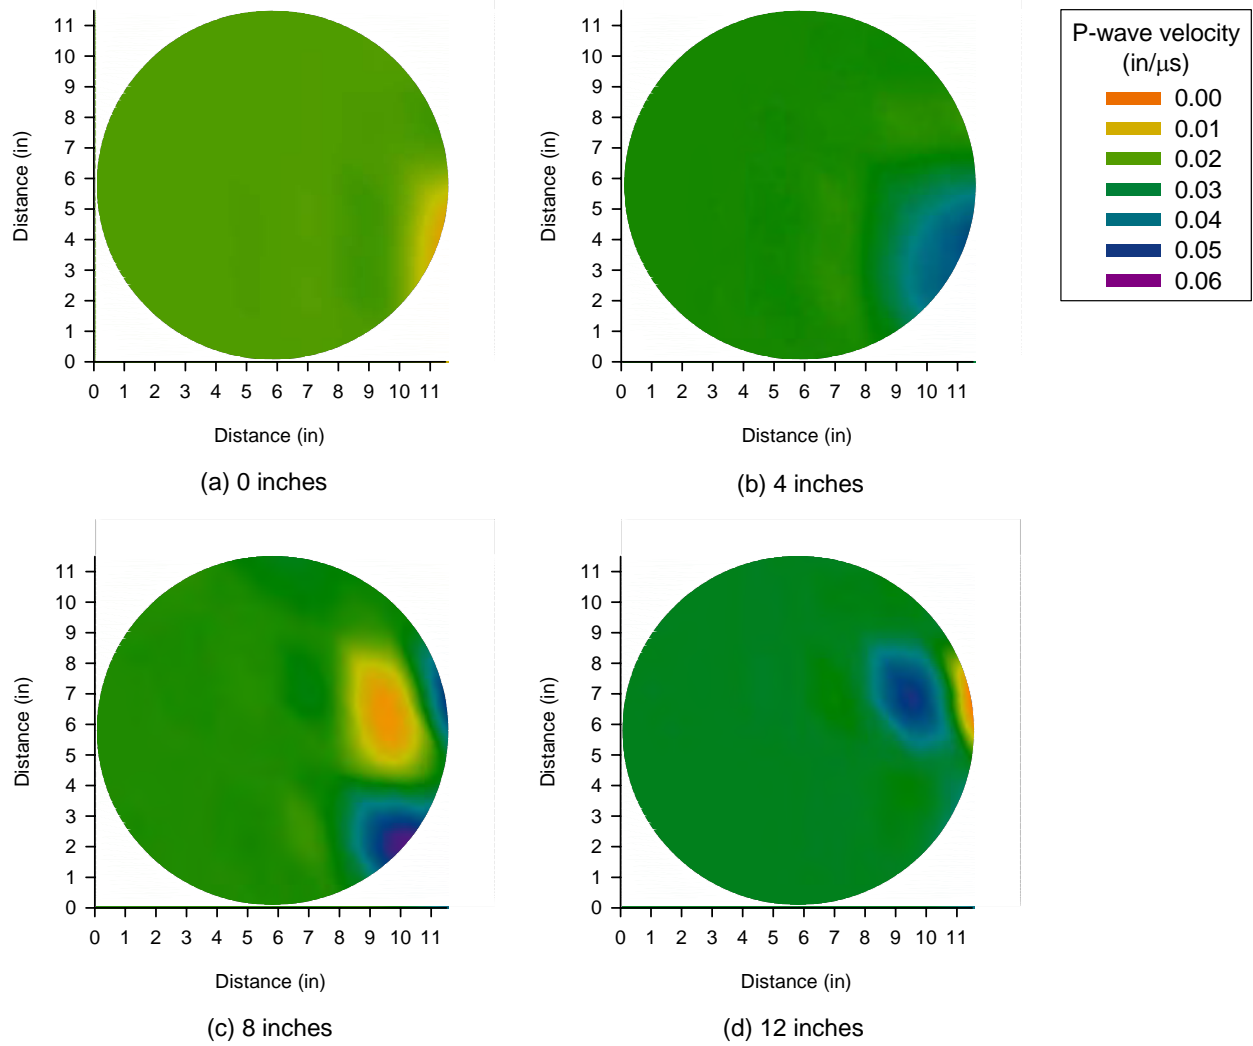
Figure B4. Pile no. 4 - Generated two-dimensional tomography images

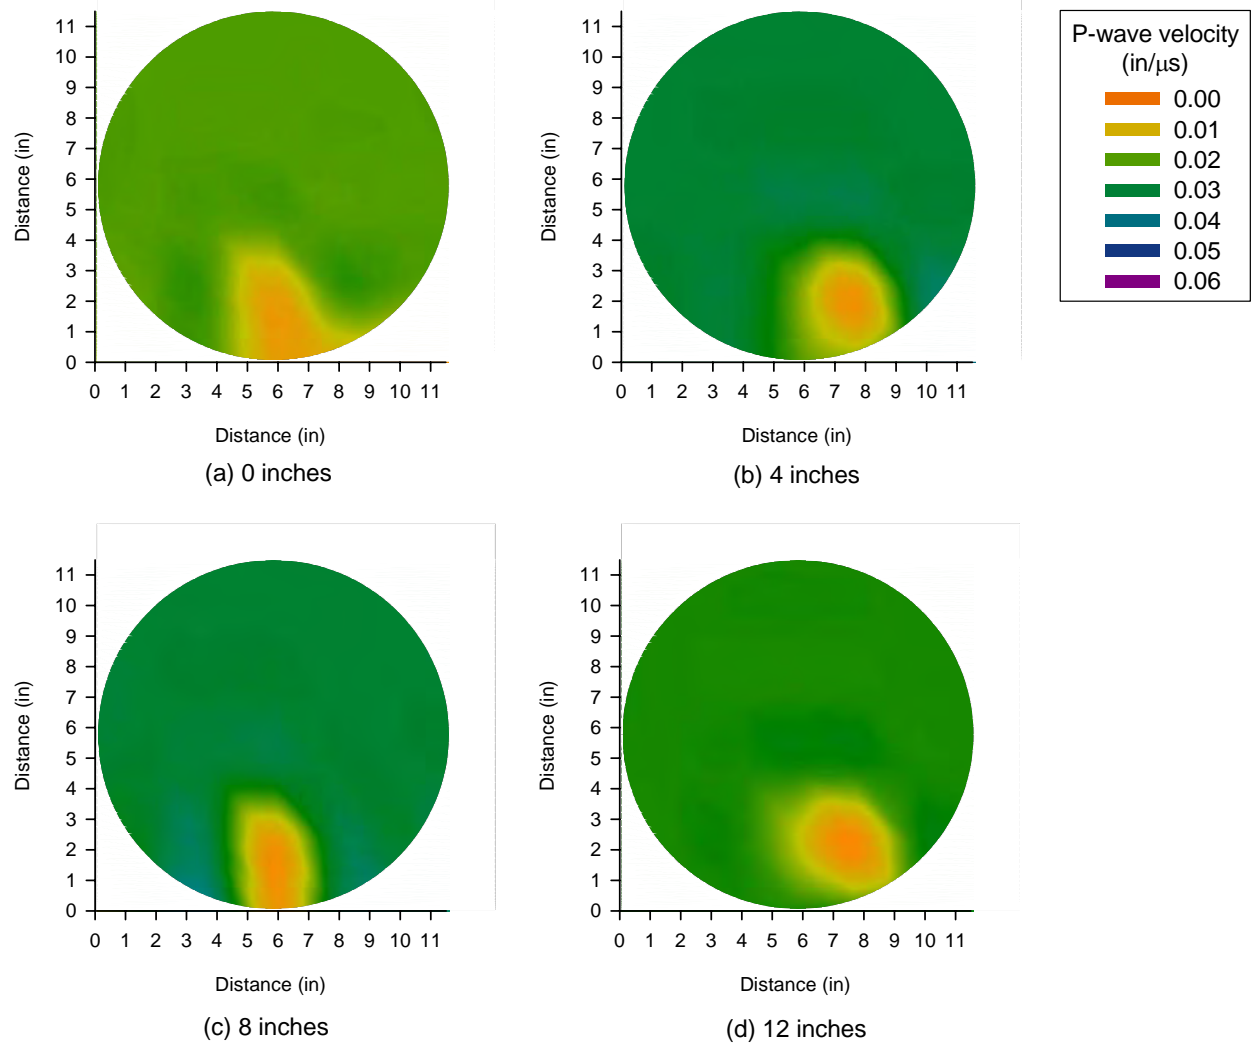
Figure B5. Pile no. 6 - Generated two-dimensional tomography images
